FULL SCALE TECHNOLOGY DEMONSTRATION OF A MODERN COUNTERROTATING UNDUCTED FAN ENGINE CONCEPT

ENGINE TEST

December 1987

by
GE Aircraft Engines
GE36 Project Department
Cincinnati, Ohio 45215

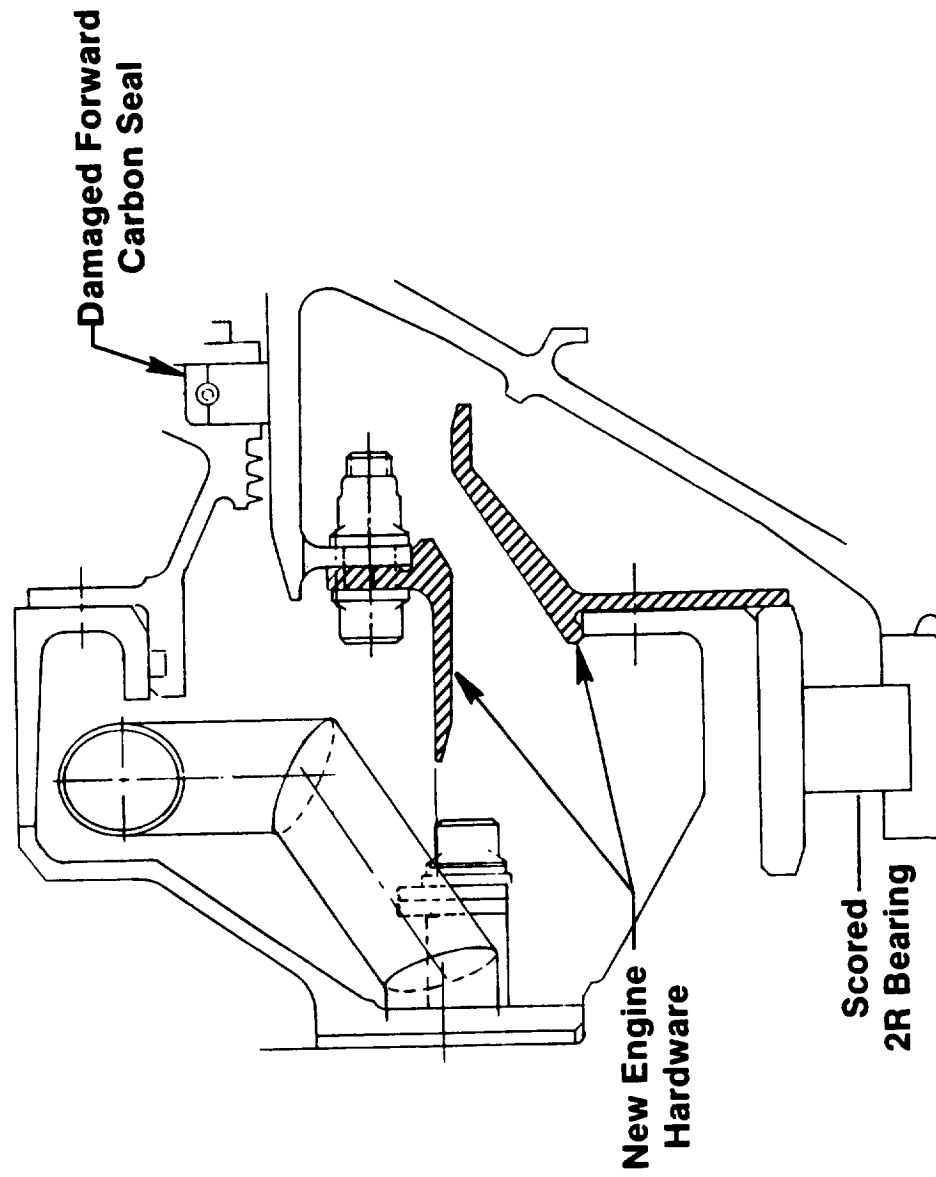
Figure 3-1. Carbon Seal Assembly Fix.

After the first engine start, the engine was shut down due to a low oil level warning. Carbon seal pieces were found in the propulsor scavenge screens. The engine was removed from the test site, and the propulsor was separated from the gas generator. After separation, it was found that the forward stationary carbon seal was damaged. It was determined that the seal was damaged during assembly. The 2R bearing was also found damaged, this due to carbon seal debris. New hardware was added to the engine to help guide the propulsor rotors together to avoid any damage to the seal (Figure 3-1), which was completely replaced with new hardware, along with the 2R bearing. The propulsor was remated with the gas generator with no problems, and the engine was put back on test. There were no oil leaks when the engine tests resumed.

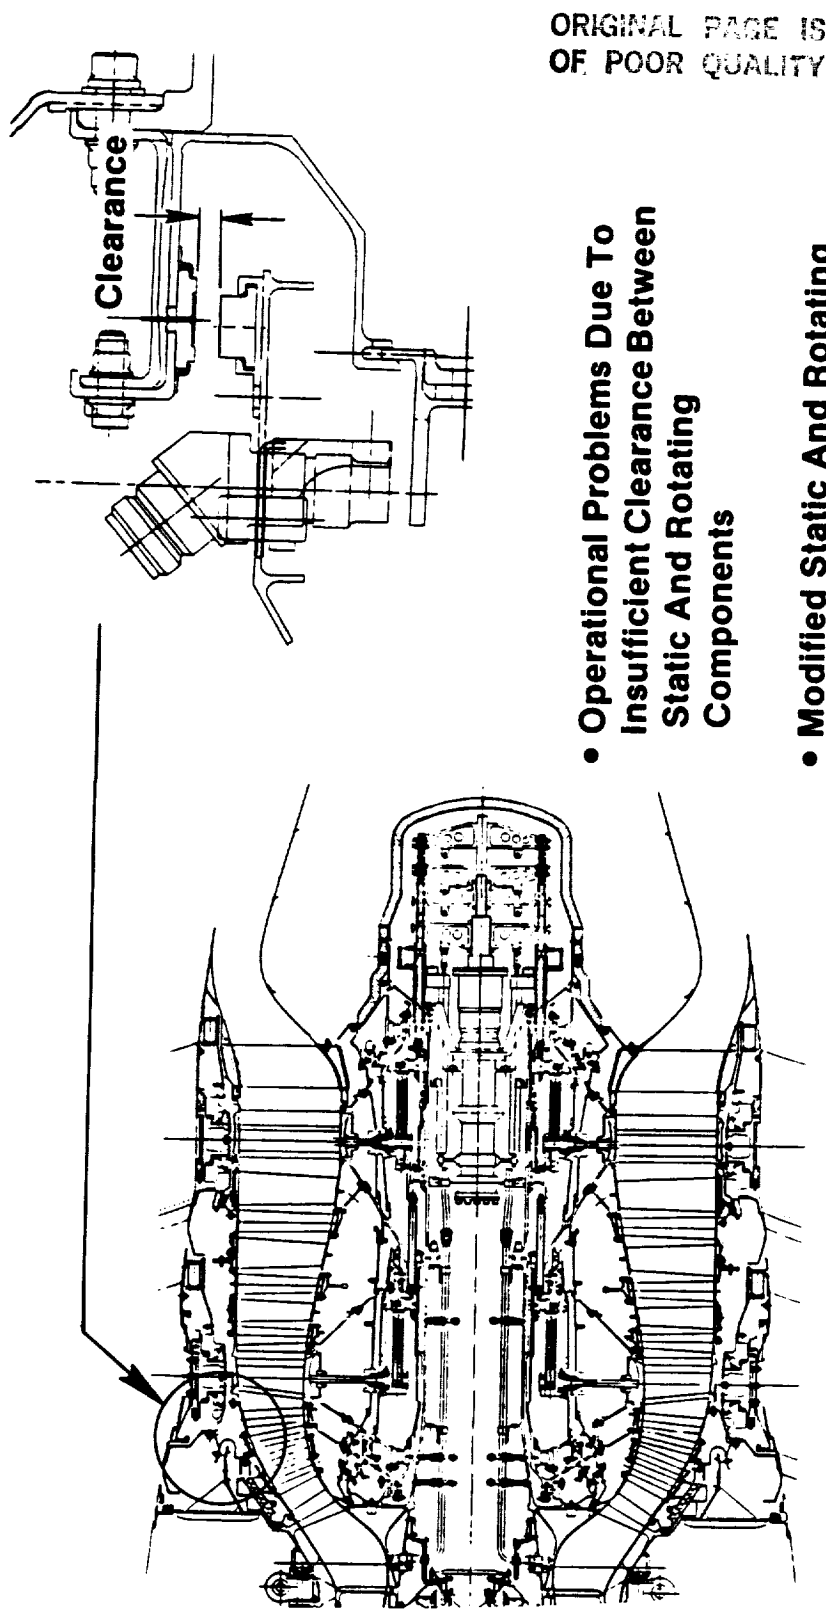
Figure 3-2. Forward Telemetry System Support.

Operational problems with the forward telemetry system were caused by insufficient clearance between the static and rotating forward telemetry antenna components. These components were modified to increase the cold running clearance from 0.135 to 0.250 inch, as diagrammed in Figure 3-2.

- Operational Problems Due To Insufficient Clearance Between Static And Rotating Components
- Modified Static And Rotating Support Structures
- Increased Cold Running Clearance - From: 0.135 To: 0.250

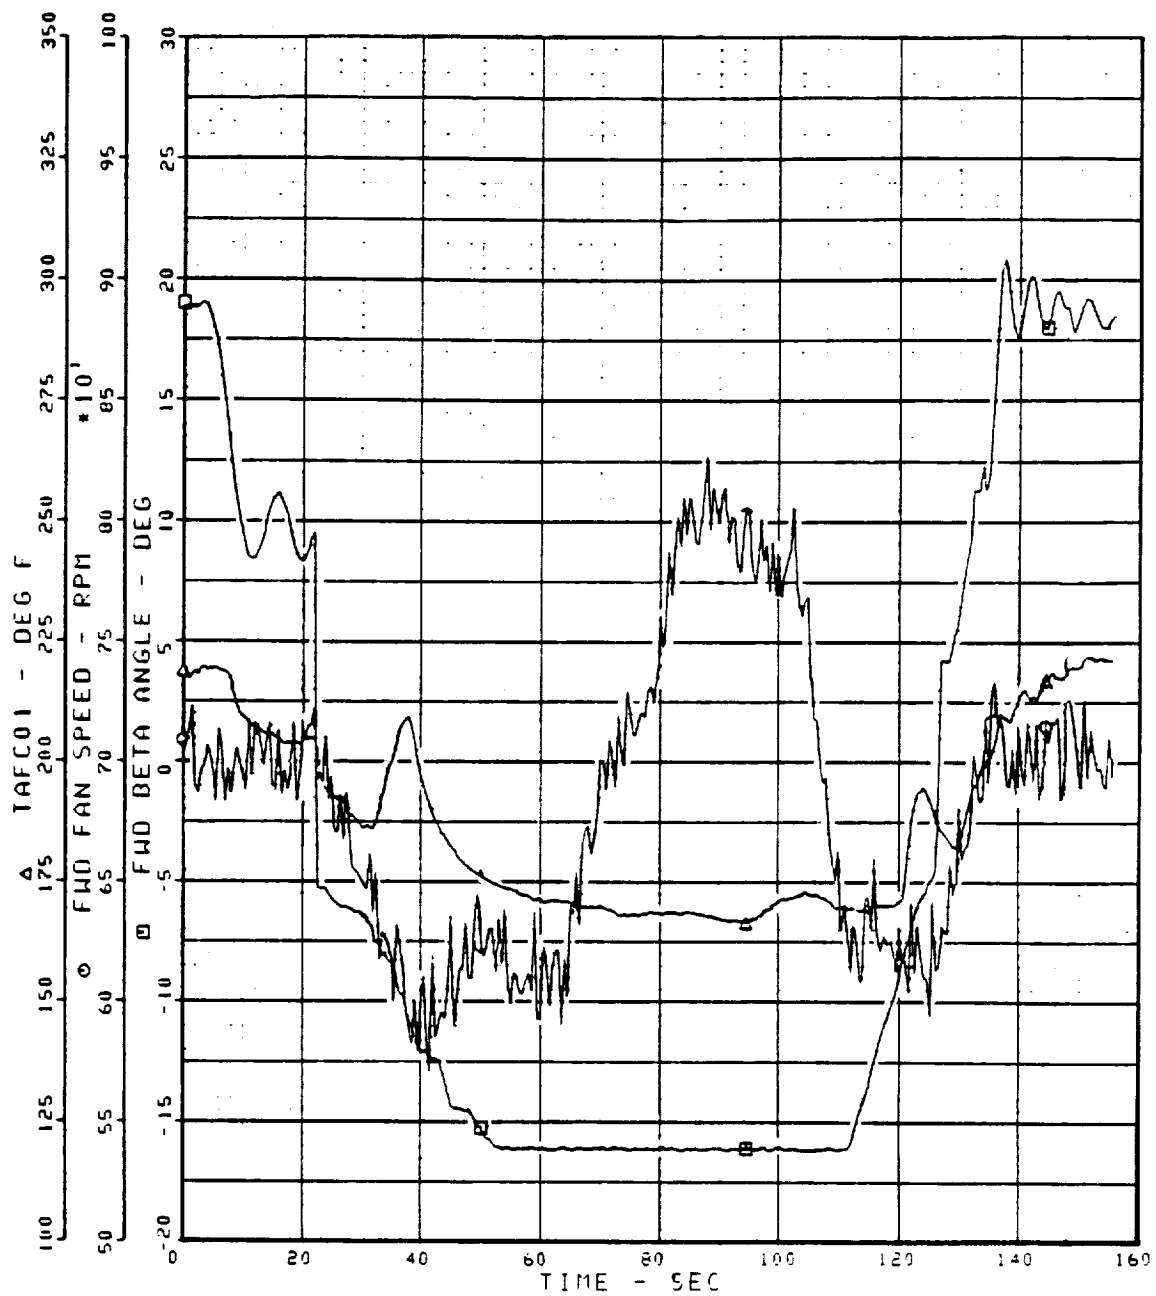
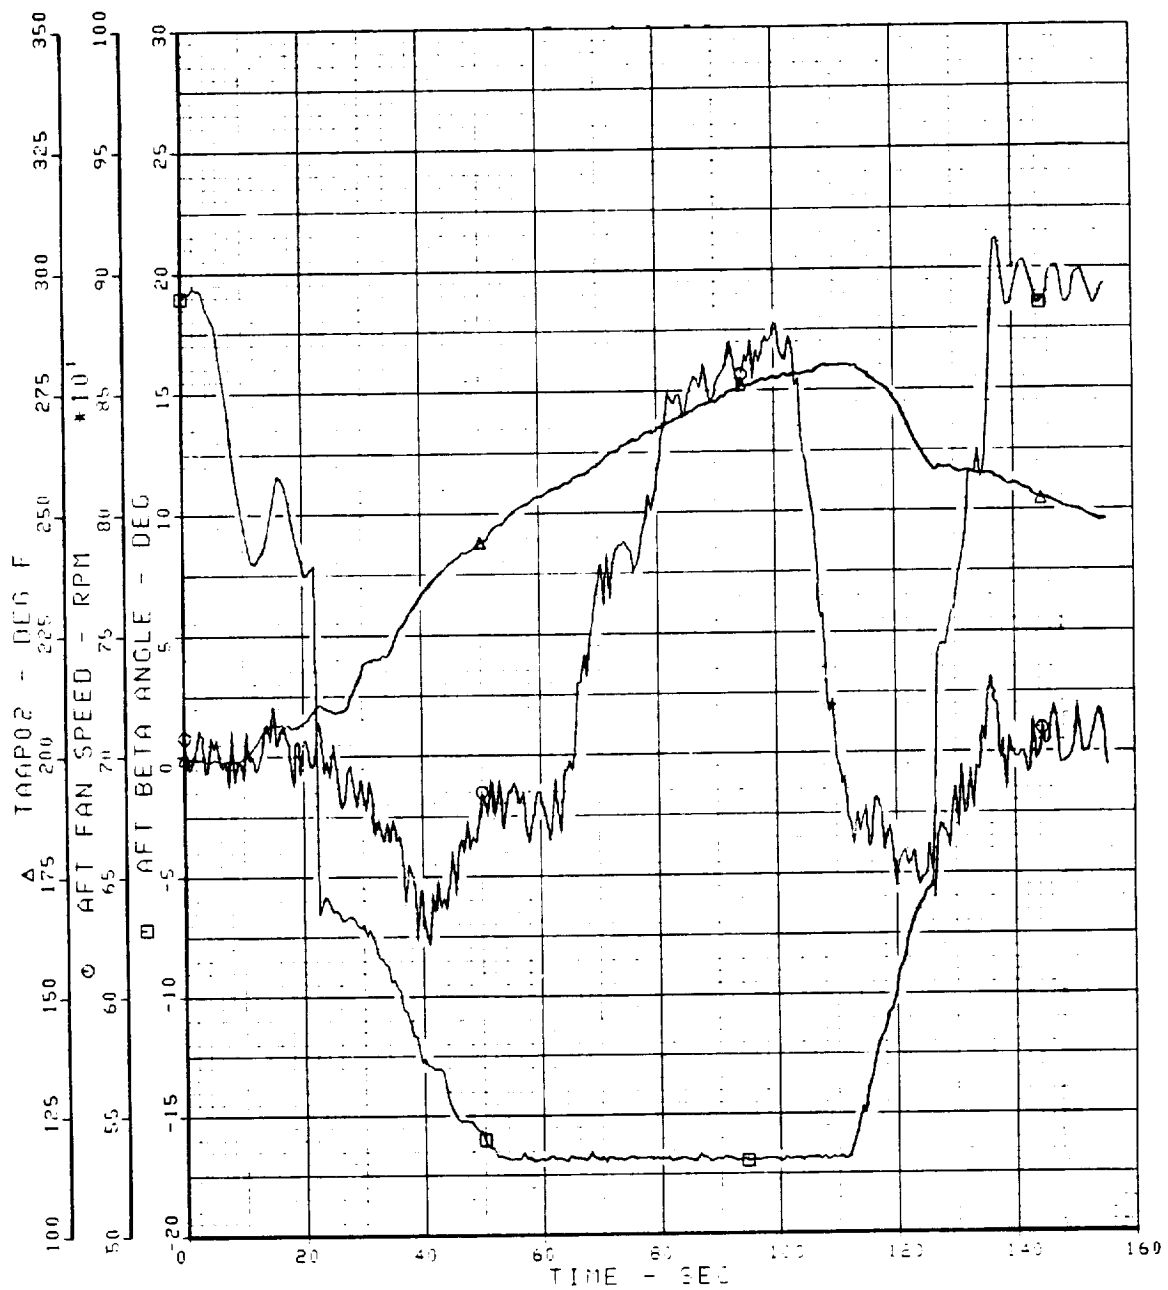
During reverse thrust testing, Stage 2 telemetry temperatures increased throughout the time the engine was in reverse. Figures 3-9 and 3-10 show the telemetry temperatures during a reverse thrust cycle. This was the fifth of a series of consecutively run reverse cycles.

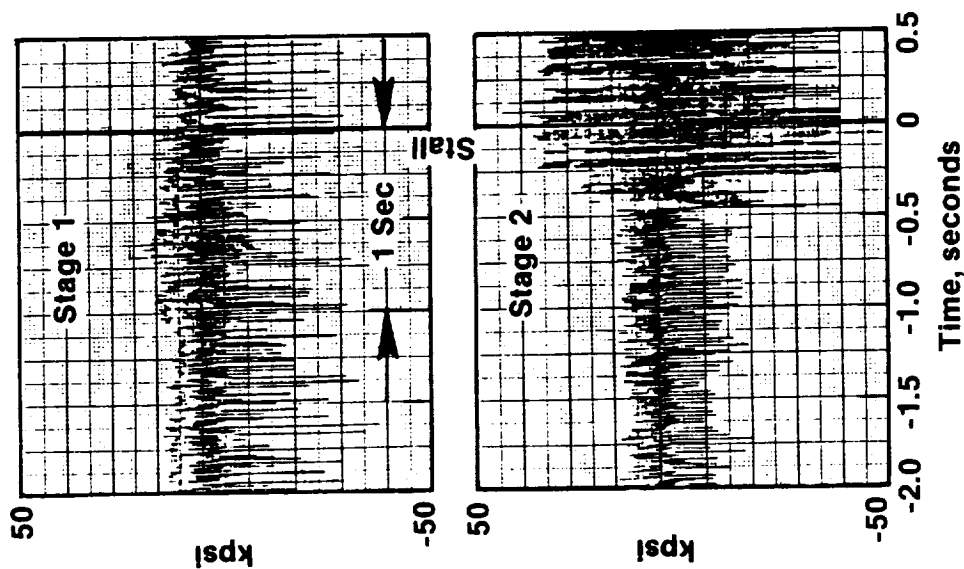
Figure 3-13. History of Turbine Blade Response, Run to Thrust and Stall.

During testing, prior to the stall, significant first flexural vibratory response had been observed on all stages of power turbine blading (Figures 3-12 and 3-13). Teardown revealed significant damage to Stage 1. Several blades had large leading edge root cracks and were leaning aft toward Stage 2. One local segment of blades was buckled aft into Stage 2. All Stage 2 leading and trailing edges, as well as all Stage 3 leading edges, were bent circumferentially and severely rubbed. Stages 1, 7, 9, and 11 exhibited severe tip rub. While Stages 7, 9, and 11 had rubbed previously during Build No. 1 due to oil leakage past a broken carbon seal, the poststall rubs were more severe. Stage 4 had very light tip rub only at the trailing edge. Stages 2, 3, 6, and 8 exhibited no tip rub. Stage 10 rubbed only one blade, which was bent at the platform. Stages 7, 9, and 11 had several bent airfoils. The rotor inner

- Morning Run Similar To 9-19-85 And 9-27-85 Runs
- Accel To 1200 - Back Off For Stage 1 20 Per Rev/1F
- Accel To 1300 - Back Off For Stage 7 8 Per Rev/1F
- Accel To Thrust - Back Off For T46
- Accel To Thrust And Stabilize
- Stress Stable Until 0.5 - 1 Second Before Stall

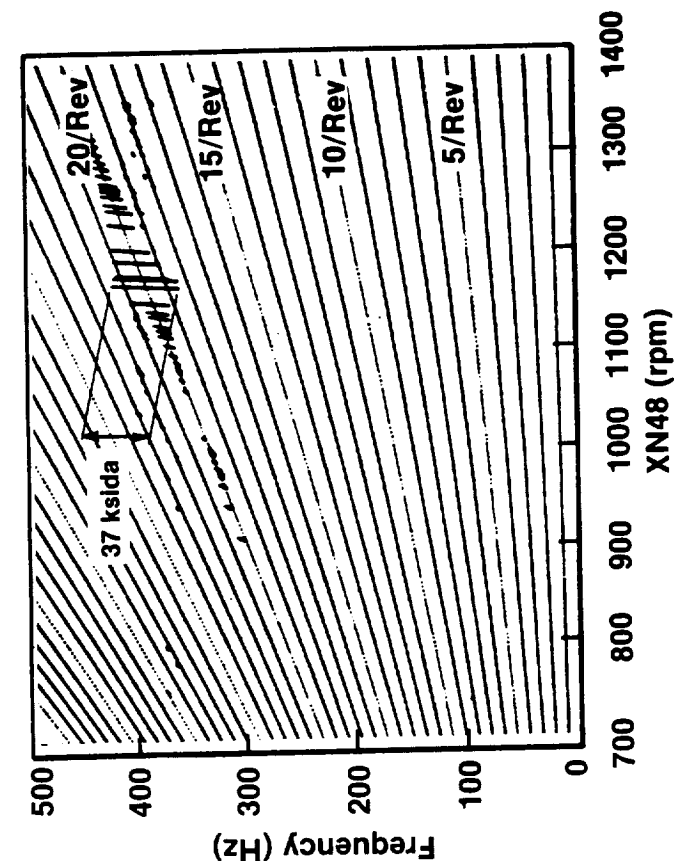
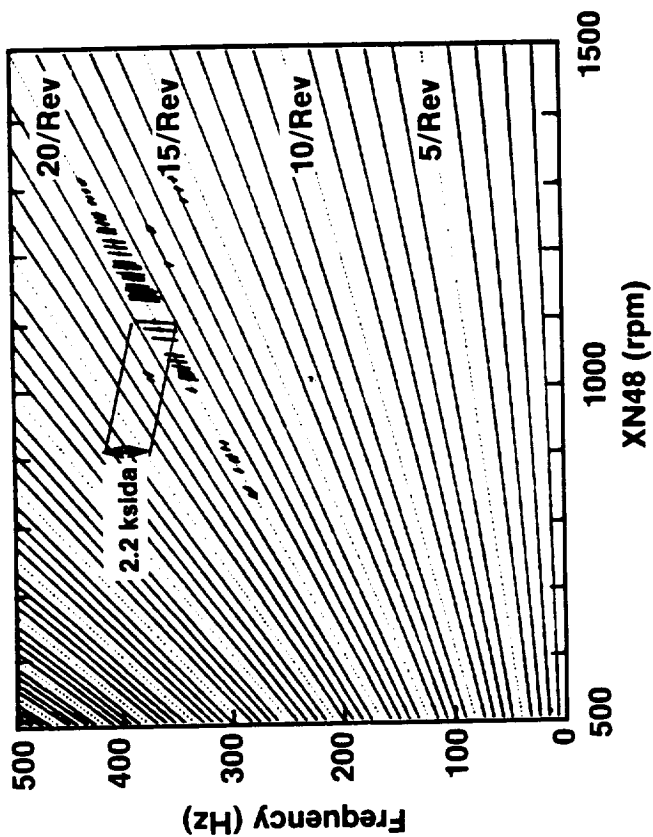
Figure 3-15. Power Turbine Blade Vibratory Response, Damper Effectiveness - Stage 1.

Coulomb damper pins were added to all turbine blade stages (1-4, 6-11) and to Stage 12 power turbine frame airfoils (Section 3.4 and Figure 3-14). Figure 3-15 demonstrates the Stage 1 turbine blade vibratory-stress reduction resulting from the addition of the damper pins. Figure 3-16 shows the Stage 1 vibratory stress in relation to the scope limits before and after addition of the dampers. Figures 3-17 through 3-26 illustrate the vibratory stress for all turbine blade stages after installation of the dampers. Data are from an accel to 25,000 lbf, except for Stage 11 blades data (bad telemetry signal) which is from an accel to 22,000 lbf. Section 3.11 contains stress data for the turbine frame blades.

Dampers Highly Effective

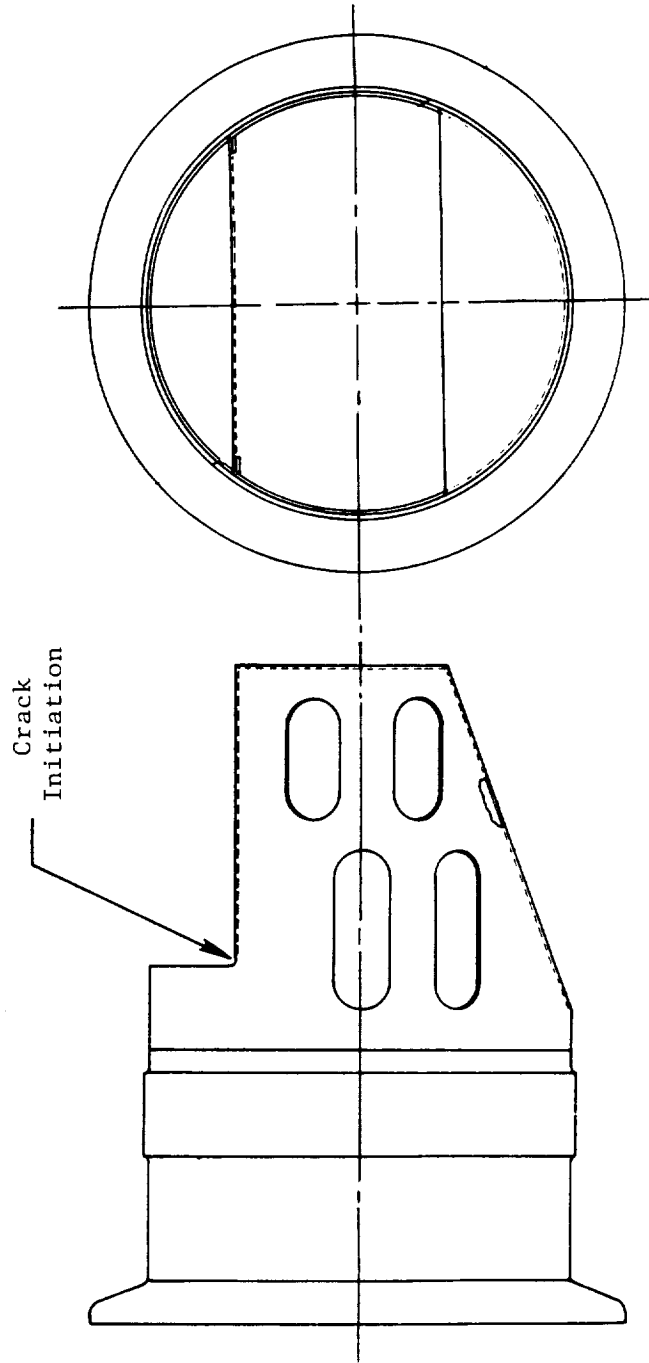
Figure 3-29. Bypass Bleed Valve Diffuser.

During Build 2, the fan bypass bleed valve diffuser failed in high cycle fatigue (Figure 3-29). Until a redesigned diffuser (Figure 3-30) could be

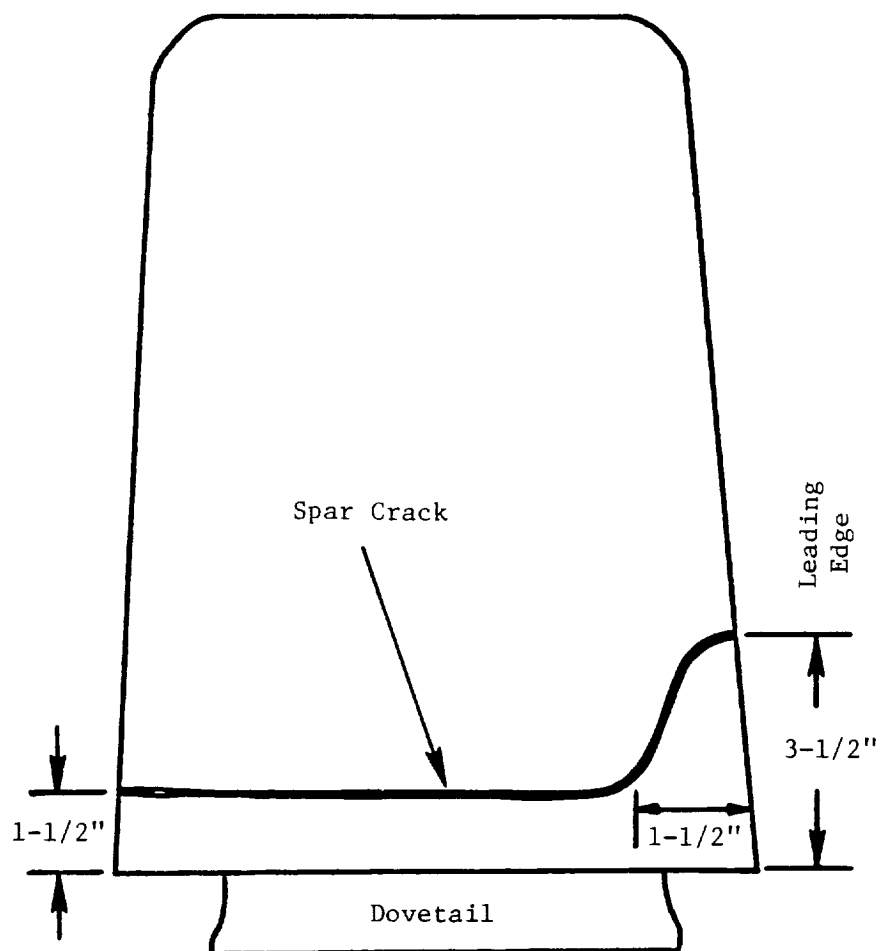
Figure 3-31. Spar Schematic.

Inspection of the spar following shutdown indicated the titanium had cracked at the EB (electron beam) weld line the entire width of the spar. The EB weld crack was clearly visible over the midspan of the blade (Figure 3-31).

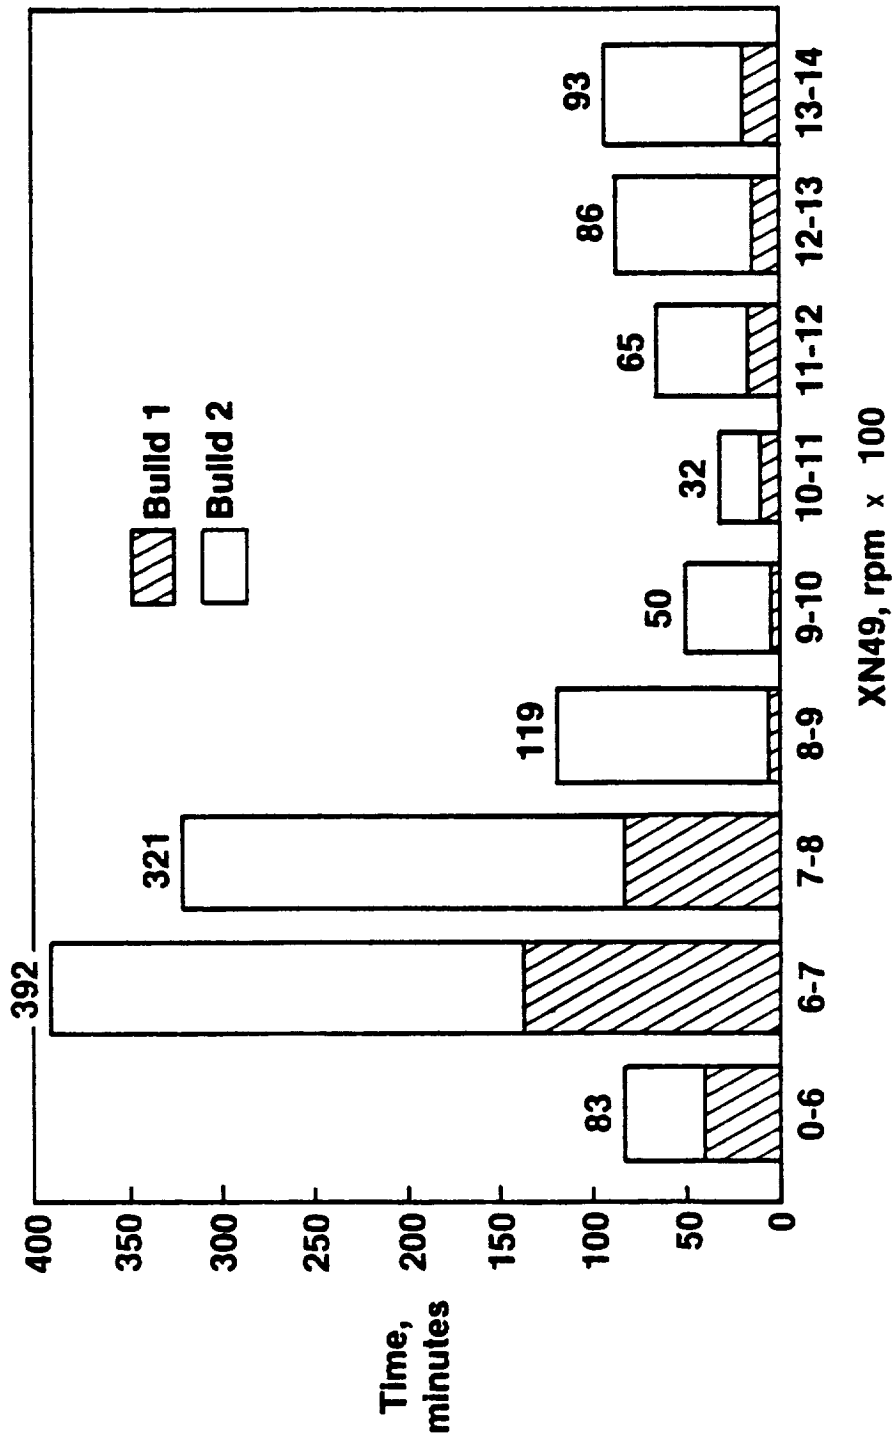
Figure 3-32. Total Run Until Fan Failure.

The blade that failed had been run 20:40 hours prior to the failure. A breakdown of run time versus propulsor fan speed is provided in Figure 3-32.

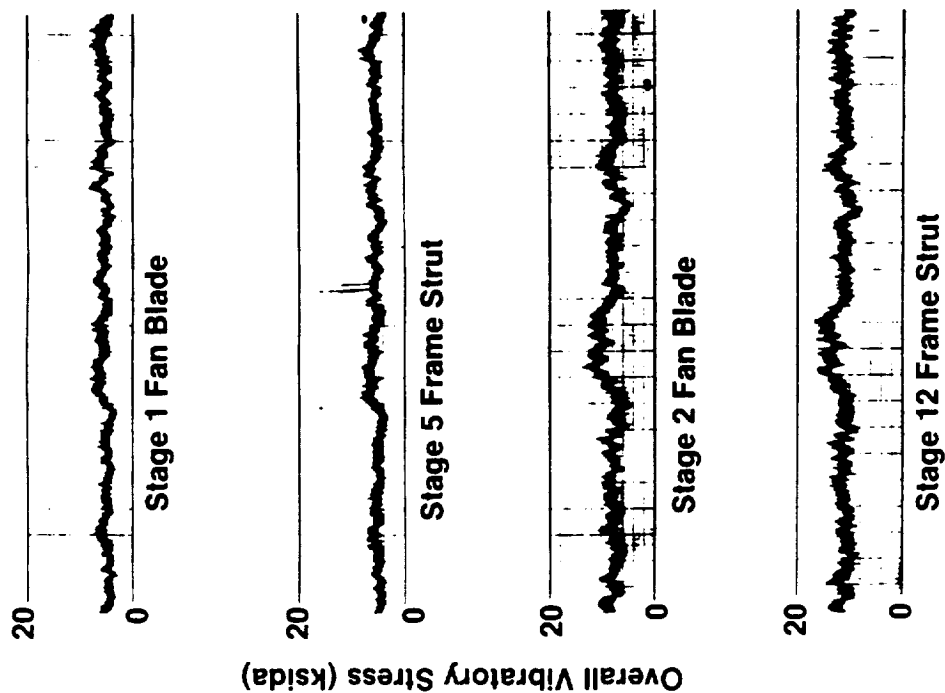
During Build 2, power turbine frame vibratory stresses were higher than predicted. The stresses were found to be predominantly 2/rev forced response. This was caused from the fan Rotor 2 nodal, first flex mode (note that the turbine frame and the fan blade rotor are mechanically linked). This causes the frame stress to track the fan blade stress. Figure 3-45 provides a stress comparison.

● Build 2 Observations

- Higher Than Expected Vibratory Stress
- Predominantly 2/Rev Forced Response
- Frames Track Fan Blades

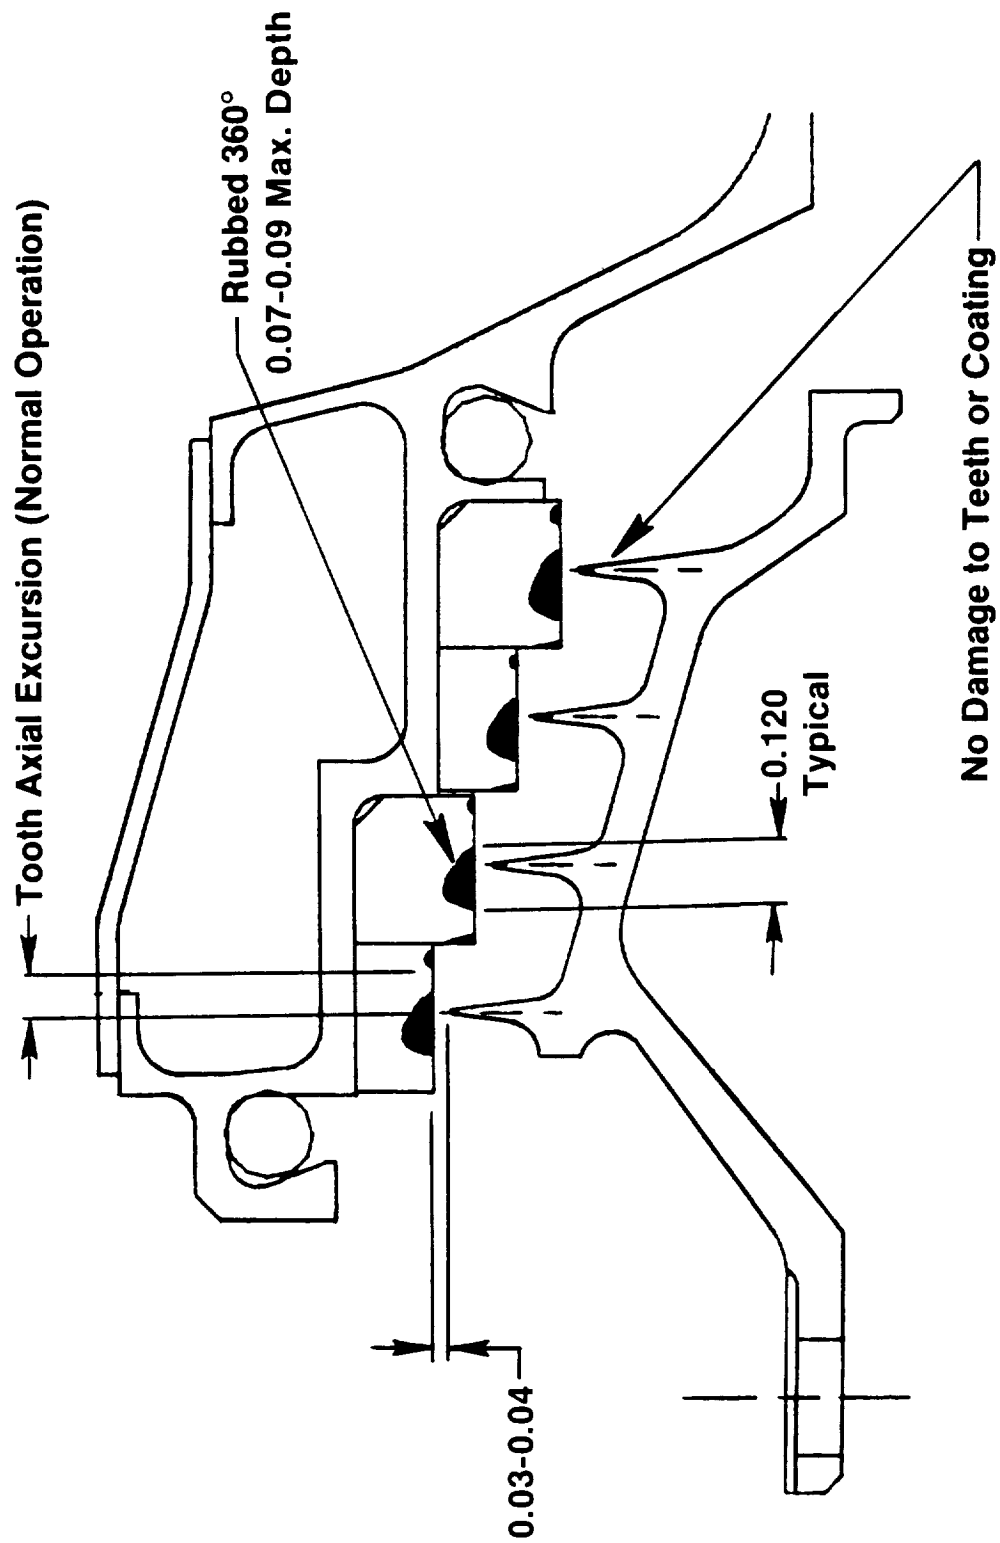
Figure 3-60. Aft Outer Flowpath Seals.

The Stage 2 polygonal ring was removed, followed by the outer seal. The seal teeth had no damage, and coating wear was normal for the engine run time. A cross-sectional view of the seal is shown in Figure 3-60.

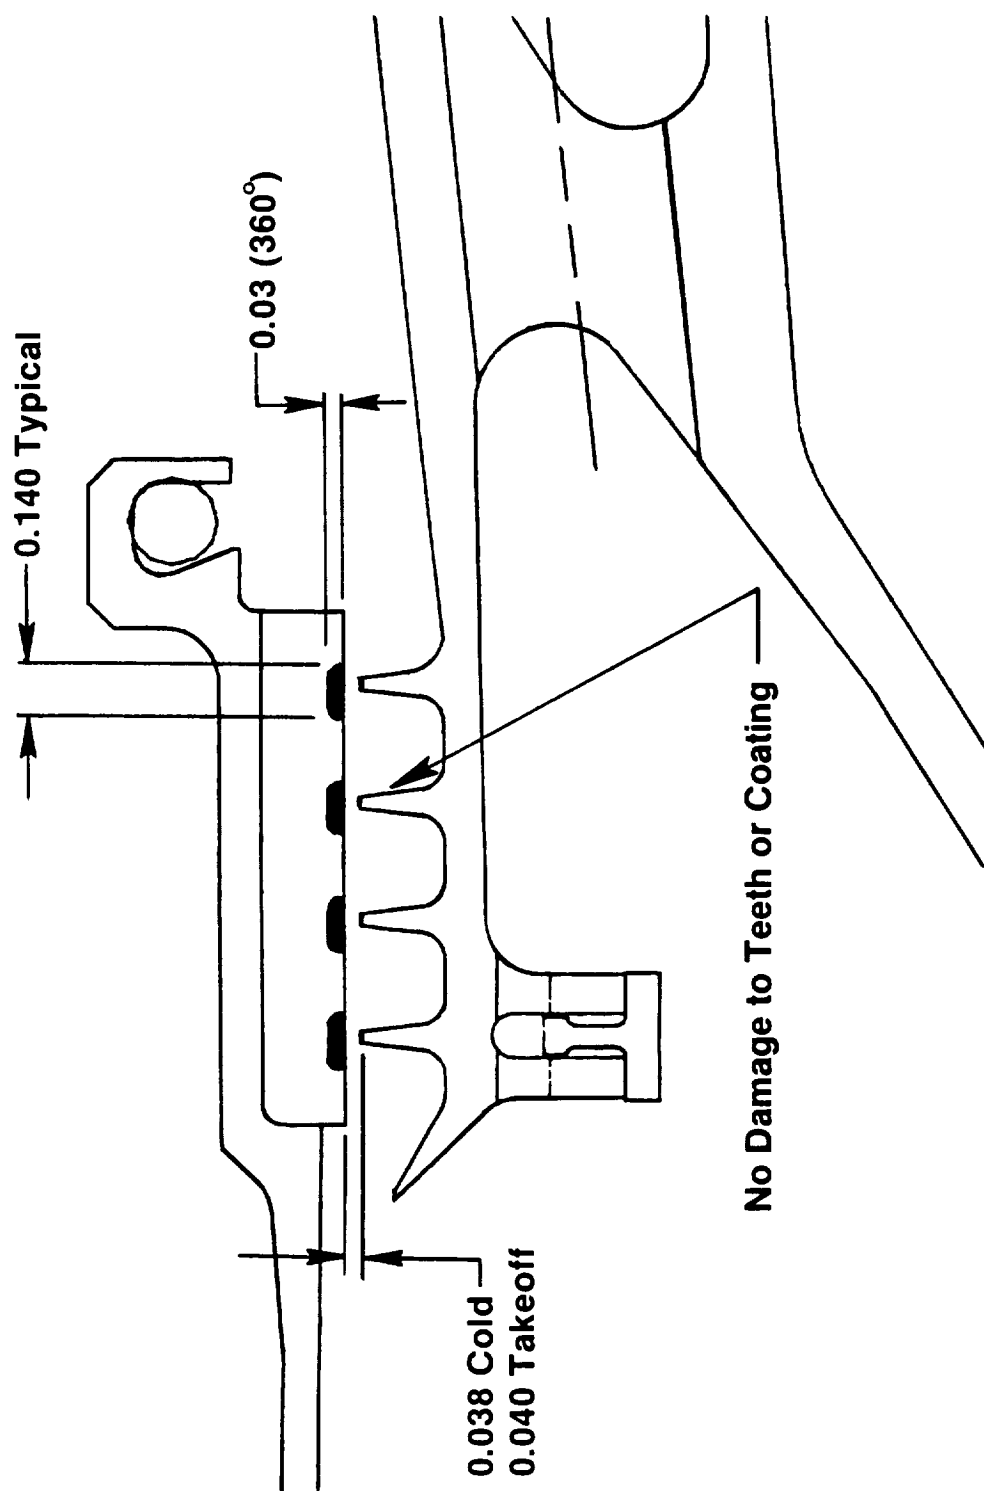
Figure 3-61. Midsump Seals.

Because the carbon seal aft of the 1R bearing, sealing the cavity, was in remarkably good condition and repairable, the seal was removed for inspection, the carbon segments were replaced, and the seal assembly installed. The mid-sump seal aft of the carbon seal had rubbed grooves about 0.14-inch long × 0.04-inch deep in the honeycomb. As shown in Figure 3-61, the honeycomb and seal teeth were all serviceable and reused.

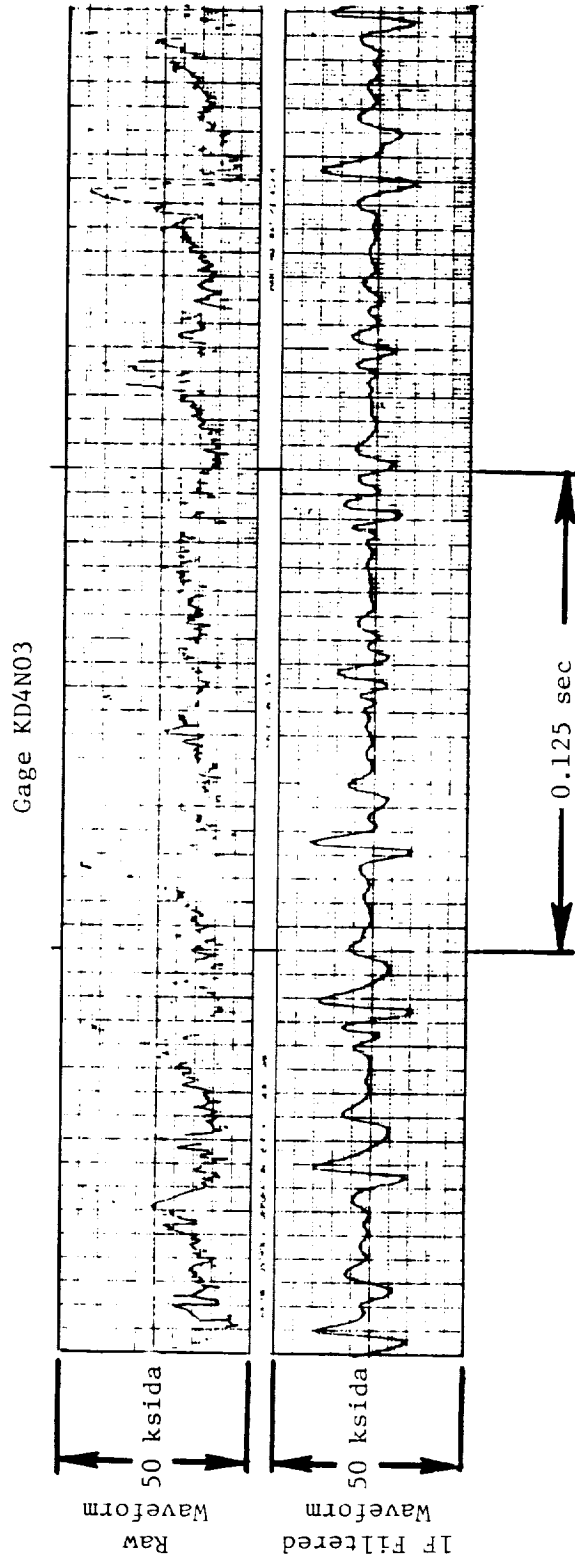
Figure 3-62. Suspected Stage 11 Rub.

All Stage 11 blades were heavily rubbed, and Stage 10 was lightly rubbed (Figure 3-62); 3 Stage 11 blades were discovered with cracks in the leading edge root, and the inner spool had evidence of a hard rub. The outer spool (odd rotor) aft stages are cantilevered from the Stage 5 power frame. If the 1R bearing were not providing adequate radial support, it would account for a rub at the aft stages of the outer spool. The 3 cracked Stage 11 blades were replaced prior to rebuild. Table 3-3 summarizes the results of the turbine blade inspection.

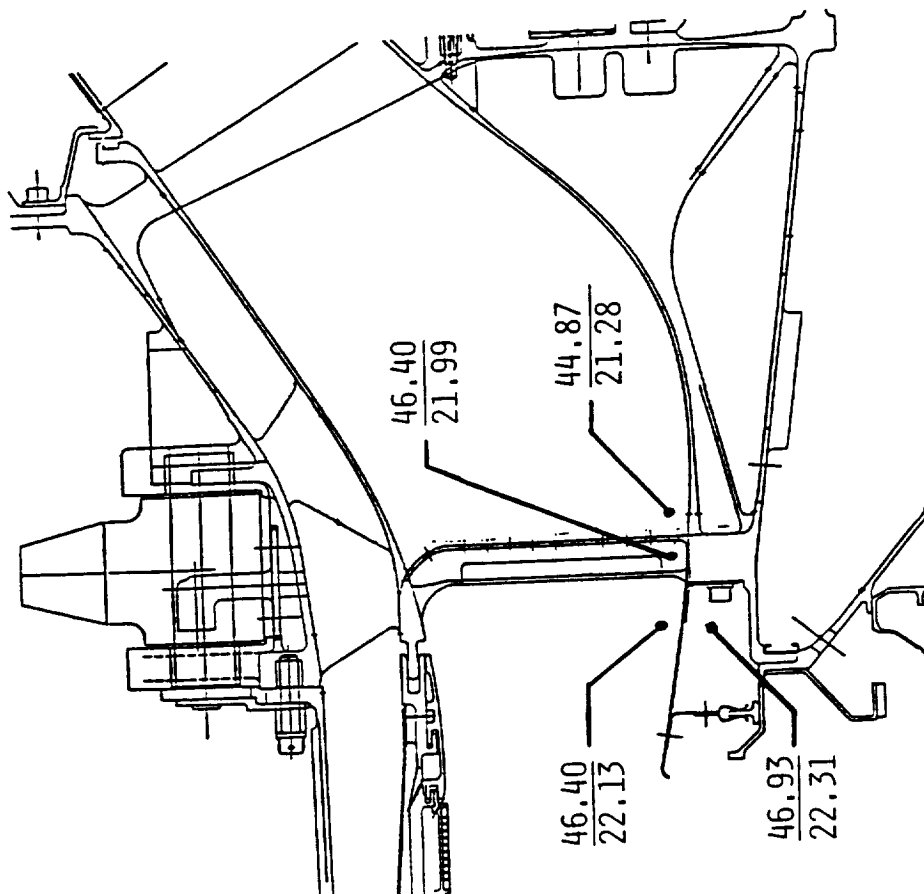
Figure 4-5. Mixer Frame Backflow Margin - Build 02 Engine.

Installation of power turbine blade dampers for engine Build 2 resulted in a lower level BFM. The inner flowpath fairing pressures for engine Build 2 are shown in Figure 4-5 for takeoff and maximum cruise, the minimum backflow condition. Takeoff pressures are taken from test data, and the maximum cruise pressures are predictions based on test results. The 0.79% BFM at maximum cruise condition is low, but it is in a very localized region. The BFM in all other regions is significantly higher.

● BFM = 1.1% AT TAKEOFF.

● BFM = .79% AT MAXIMUM CRUISE CONDITION.

- INSTALLATION OF POWER TURBINE
BLADE DAMPERS.

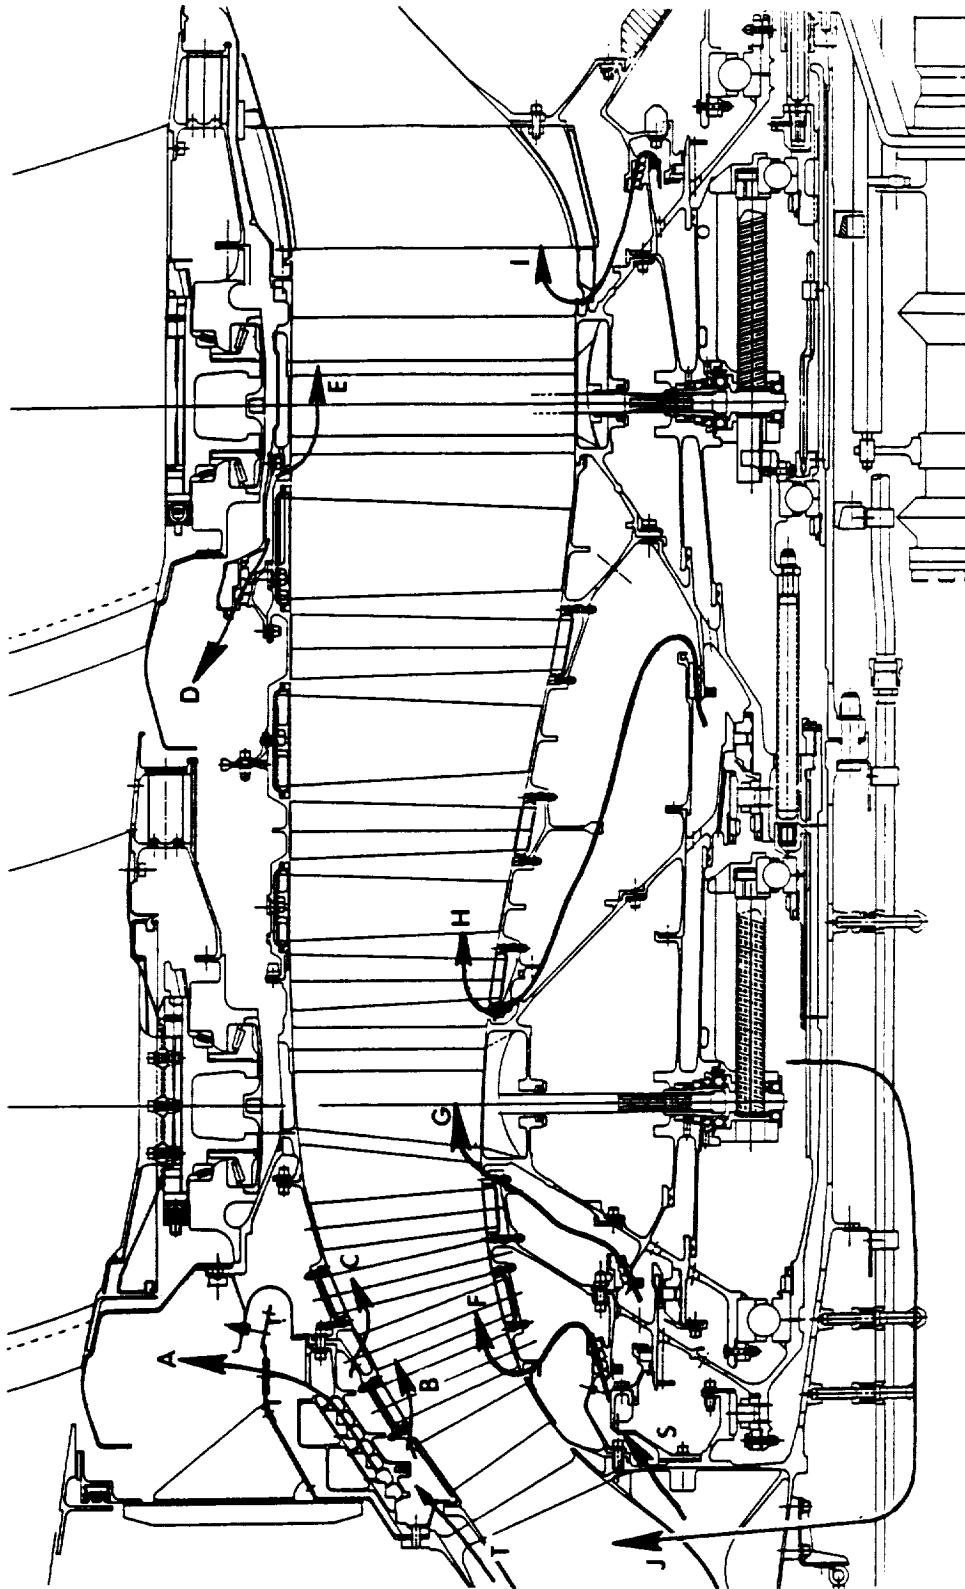
Figure 4-7. Power Turbine Secondary Flow Circuit.

Figure 4-7 illustrates the power turbine secondary flow system. The flow rates, predicted and actual, are tabulated in Table 4-1. Although the total secondary flow for engine Build 1 neared prediction, the Stage 1 inner flowpath purge flow was significantly lower than predicted. This redistribution of flow is a result of a mixer frame supply hole flow coefficient that is lower than predicted and shafting hole flow coefficients that are greater than predicted. The increased pressure drop across the mixer frame supply holes, combined with reduced pressure drop through the shafting annular holes, serves to lower the supply pressure to the forward seal. Also, the sump vent flow was higher than predicted due to large carbon seal leakage areas. This additional vent flow results in a further decrease in Stage 1 purge flow.

During Build 1 testing, Stage 1 cavity temperature was 830° F at takeoff power, as compared to 795° F predicted. Although there was no evidence of gas ingestion, it was observed that the forward seal ΔP decreases with increase in power setting. Figure 4-8 plots ΔP versus P46Q2.

During Build 3 engine testing, rubs occurred on two middle inner flowpath seals (G and H). There is an increase in the flows of these two seals, but because the system is metered for the most part by the supply hole and the shafting holes, the total secondary flow increases only slightly (Figure 4-7).

- PROBLEM: EXTRAPOLATION OF TEST DATA INDICATES THAT FORWARD SEAL COULD BACKFLOW AT MAX POWER.
- CAUSE: UNDERSIZED SUPPLY HOLE AND OVERSIZED ANNULUS HOLES REDUCE THE SEAL SUPPLY PRESSURE.
- SOLUTION: INCREASE SUPPLY HOLE AREA.

Extrapolation of the test data indicates that for Build 1 testing, backflow could occur at maximum power. To maintain positive flow in all cases, the mixer frame supply hole area was increased from 5.4 in² to 5.84 in². The resulting increase in forward seal ΔP from Build 1 testing to Build 2 testing is significant (Figure 4-8); however, the impact of this area increase on the remaining purge flows is negligible. The aft labyrinth seal flow increased significantly from Build 1 to Build 2 testing, presumably due to an increased seal clearance, indicated by a reduction in pressure drop across the seal.

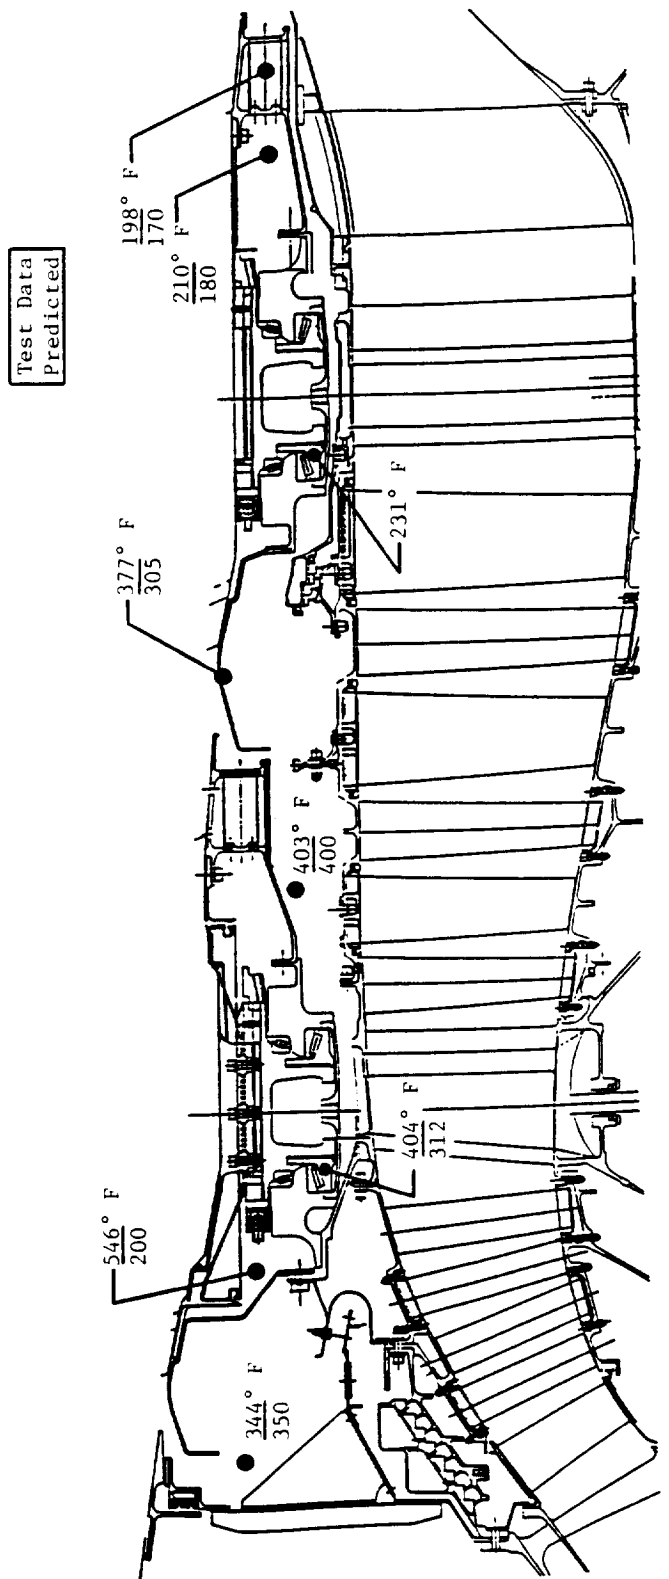
Figure 4-12. Nacelle Temperatures Based on Test Data at Takeoff Power.

The nacelle ventilation system is depicted on Figure 4-12, with component temperatures at takeoff condition. All thermocouple data have been scaled up to hot day conditions, as described in the mixer frame section. Although some components are higher in temperature than predicted, all of the hardware is adequately cooled.

During initial engine Build 1 testing, ambient air was to be brought in to the nacelle cavity aft of the Stage 2 telemetry through radial holes in the cowl. However, poor ventilation in that region led to an overheating of the aft telemetry, probably due to a low level of static pressure at the inner flowpath. A total of 30 air scoops were then mounted to the holes. The additional ventilation air resulted in the temperatures presented in Figure 4-13.

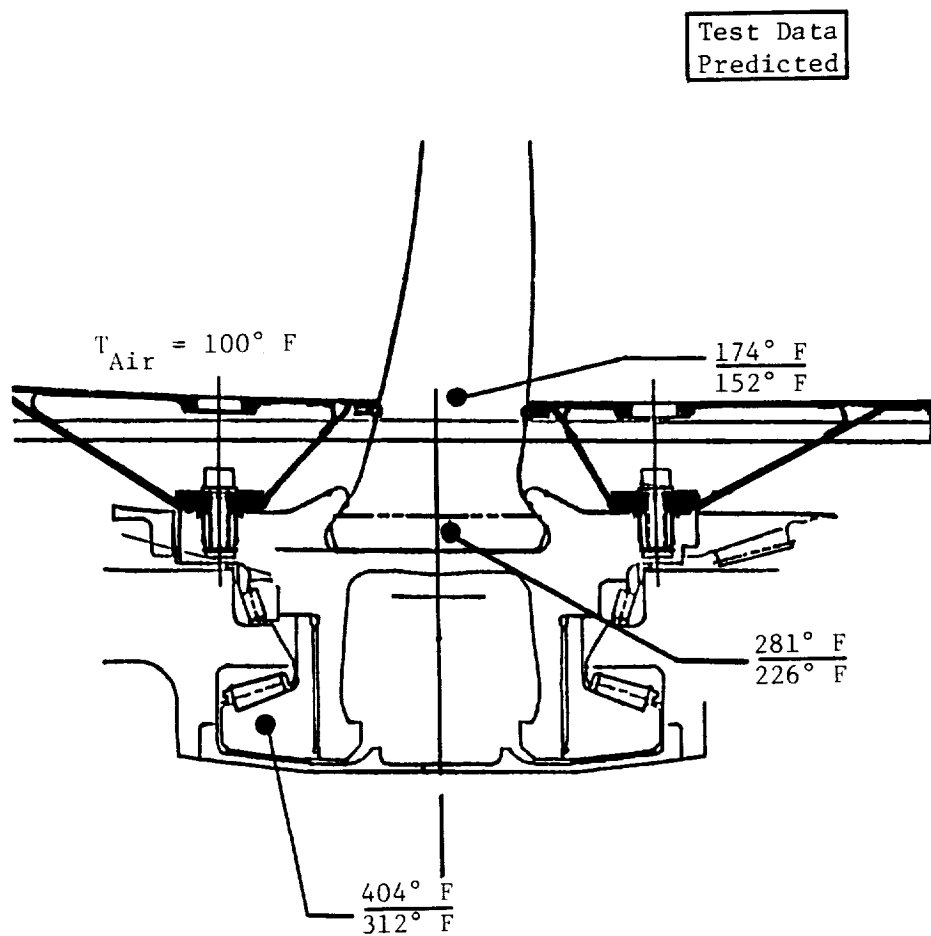
Figure 4-13. Forward Fan Blade Hub Temperatures; Hot Day Takeoff, Mach = 0.0, Full Thrust.

Figure 4-13 gives a breakdown of the forward fan blade hub temperatures for hot day takeoff. The 404° F trunnion temperature is taken from thermocouple data. All other temperatures are determined by rebalancing the heat transfer model on the basis of the trunnion temperature. All temperatures are higher than predicted, but are still within allowable limits.

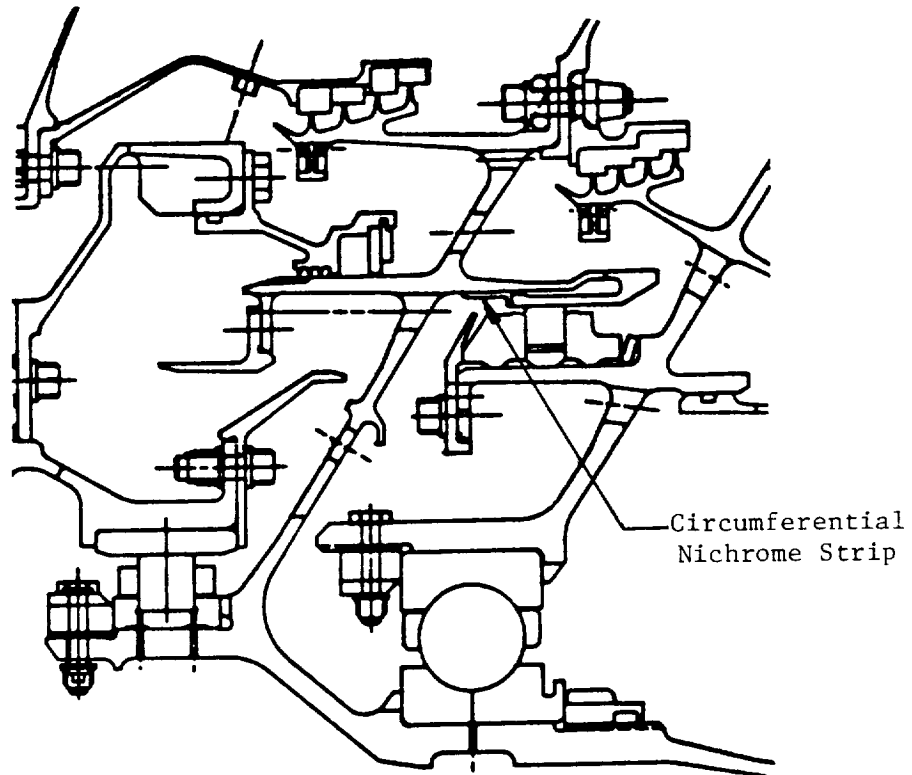
Figure 6-1. Seal Cavity Closure.

The two roller bearings were replaced twice during ground testing when they were exposed at disassembly. They were replaced because debris damage had scored some of the rollers. The debris was comprised almost exclusively of 0.007-inch-diameter steel shot particles, with some other manufacturing and wear debris present in very small quantities. Prior to engine teardown, oil sample analysis had identified the possibility of a debris problem.

Causing extensive scoring of the rollers, the shot became imbedded in the soft silver plate of the rolling element retainer of the bearing. This would cause both a breakdown of the hydrodynamic lube film because of the high loads and low rotational speeds and a diminished fatigue life. However, no surface distress due to rubbing was observed.

To prevent further debris damage, the blind cavity was ultrasonically cleaned and sealed closed with a nichrome strip (Figure 6-1). This was fairly successful, although one or two pieces of shot were still found in subsequent oil samples.
